**SAS Superstructure**

Location: 04-SF-80-13.2 / 13.9

Daily Diary Report by Bid Item

Diary #: 152 Const Calendar Day: 351 Date: 25-Aug-2010 Wednesday

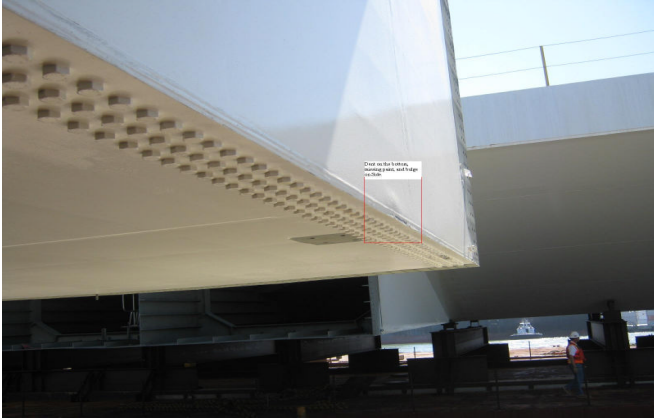
OBG Lift 7E:

There are small areas of rust and missing paint, (scuffing, tape removal, etc.). See the attached picture for a small area that may have been damaged during transport. There was also what looked to be an arc strike on the top portion of the CB8 extension of Lift 7E. See Picture.

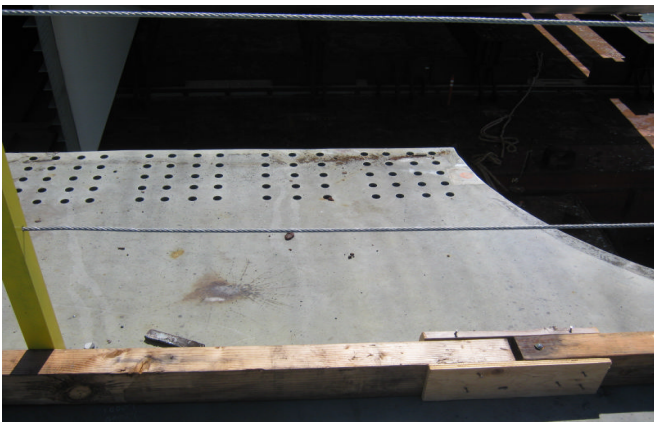
OBG Lift 7W:

There are small areas of rust and missing paint, (scuffing, tape removal, etc.). One small spot on the drip rail is bent. See attached picture.

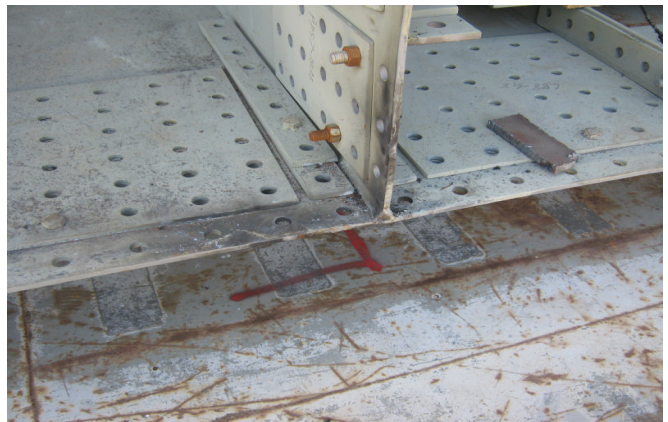
CB7, 8, 9, and 10:

There are areas that the sea fastening rubbed the paint off, and rust in small locations. At CB8 there was some flame damage on one of the corners. See picture.
